**EAGLE LAKE DAM**

**MA 00979**

**PHASE I INSPECTION REPORT  
NATIONAL DAM INSPECTION PROGRAM**

**AUGUST 1978**

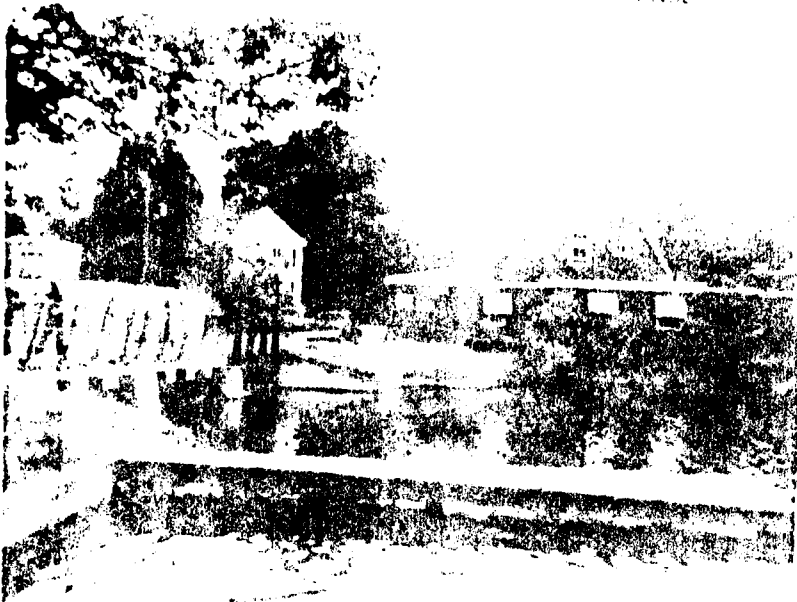
2

Upstream View of Dam from Left Bank

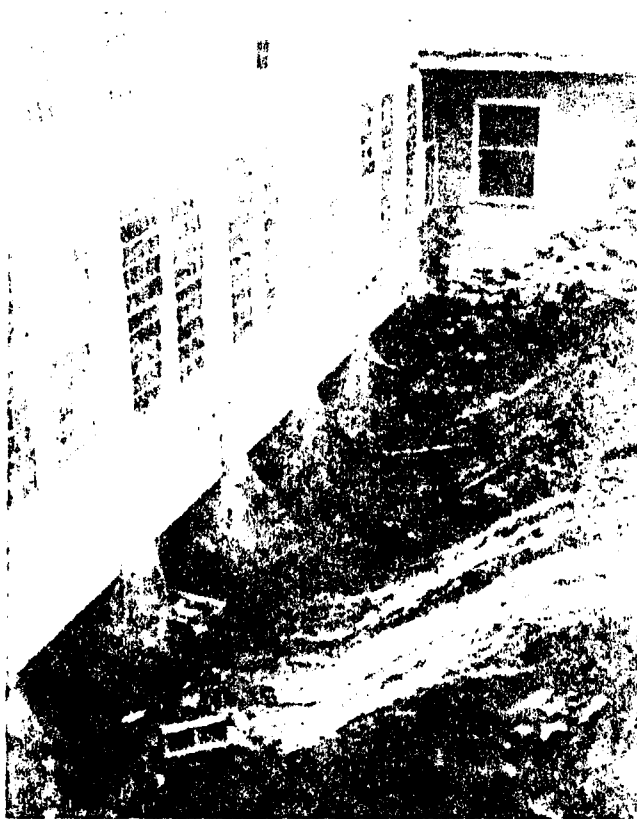
3

c. Visual Observations. Space between top of stoplogs (and gates) and underside of bridge could plug easily. Some growth and debris was noted on the downstream side of the structure. Overflow of the right abutment would flow onto Main Street.

Downstream View of Spillway from Bridge

(3) Growth should be removed from the spillway structure, and debris removed from the downstream channel as far as the Main Street bridge.

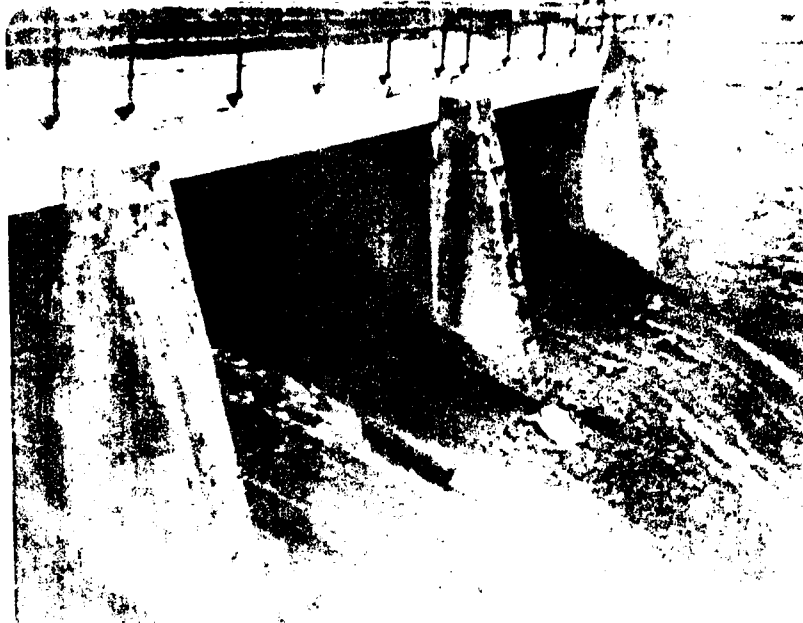
4

Downstream View of Spillway  
from Right Bank

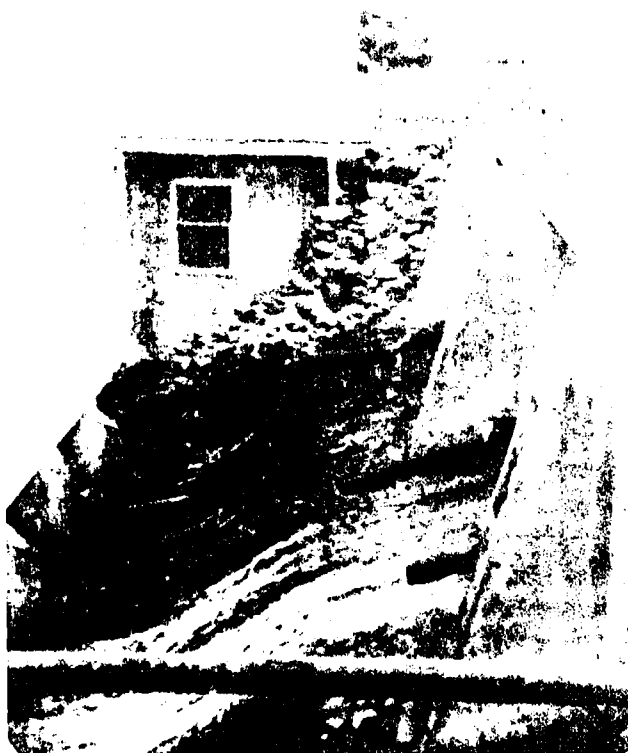
5

Downstream View of Spillway  
from Left Bank
